Cleaner belts for Fulton Hogan

Having trouble with significant amounts of material being carried back along the underside of your conveyors? Fulton Hogan's Poplar Lane quarry in New Zealand found a solution.

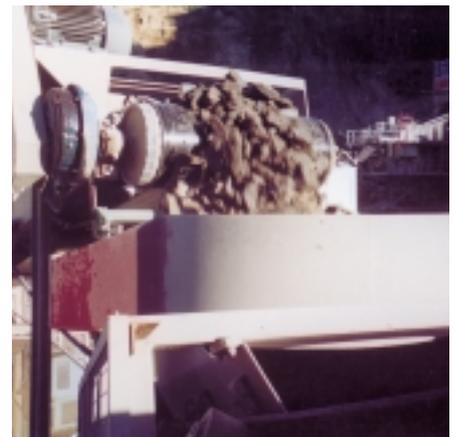
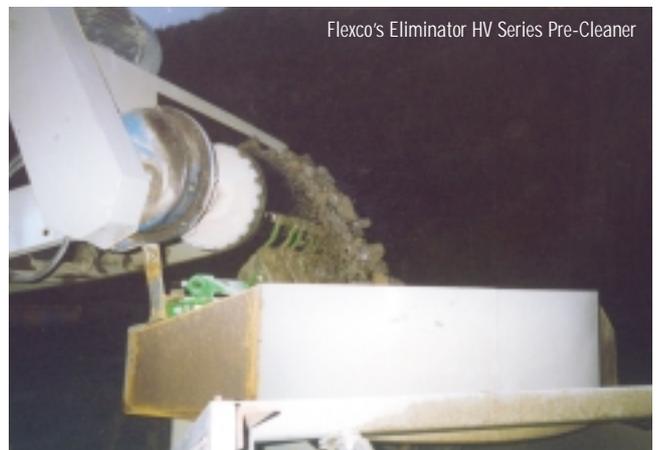
Flexco's Eliminator HV Series Pre-Cleaner

The proposal was to implement a trial of the Flexco Eliminator HV Series Pre-Cleaner, one mounted directly onto the conveyor's head drum. The preferred cleaner was to be installed on the feed conveyor system. The Eliminator HV Series cleaner was chosen from Flexco's broad range of conveyor belt cleaning systems. These cleaners have a robust and compact construction and the low profile of their tips kept them positioned

below the flow of material. In turn this would increase tip life, improve cleaning efficiency, reduce down time and attack the additional costs attributed to tip change outs.

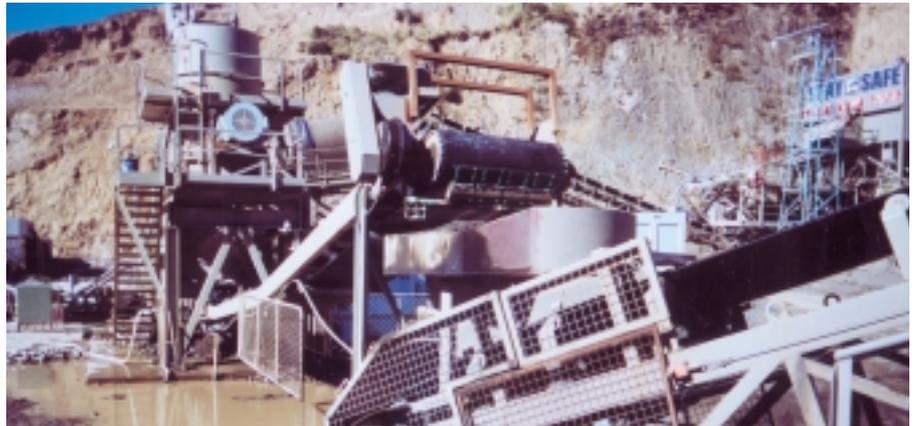
The Eliminator has helped reduce mess on the plant floor

back was dramatically reduced, with between 85-90% reduction in material carry back.
